Inspection Job ID: 090920-1

HIGH BAR

Inspection Report

Client Name:	Herman Munster
Address:	1313 Mockingbird Ln
Inspection Date:	September 24, 2020

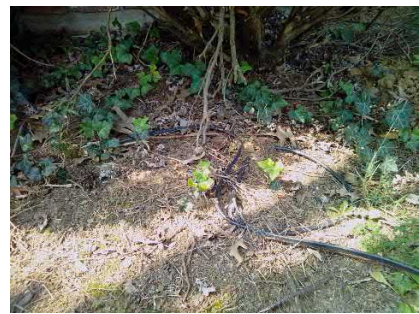
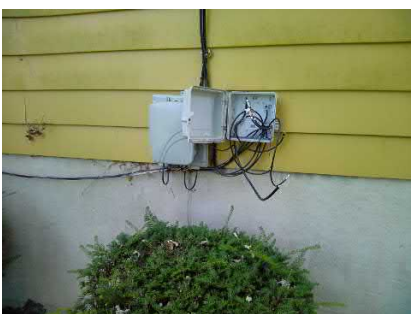
Data, Telephone, CATV, & Low Voltage

Disconnected Cable. Loose data and cable running along front of home. Not a dangerous condition, but in need of correction if desired.

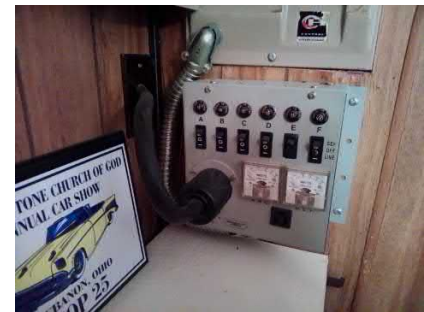
Sub-Panels

Generator hookup present, but no generator.

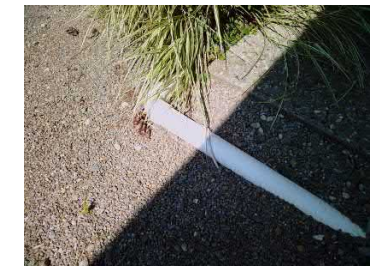
Other Electric

Electric to lamp post near detached garage was not run through conduit. Correction by qualified electrician recommended.

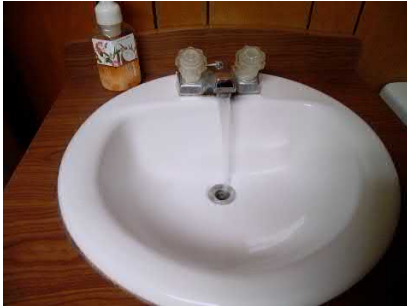
Interior Water Supply & Pressure

Poor water pressure when multiple faucets were on in downstairs bathroom.

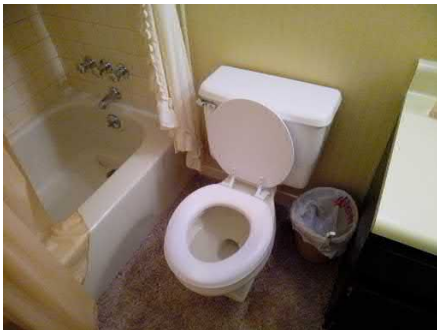
Toilets

Upstairs toilet would not flush the bowl when activated. This may be a symptom of poor water pressure, or a clog in the drain lines. Further inspection by a qualified plumber recommended.

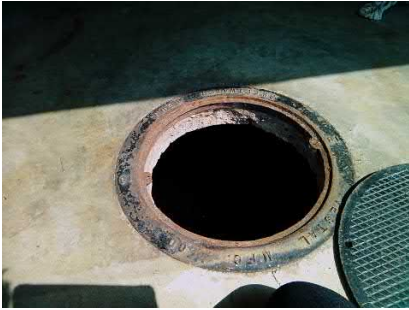
None present, though cistern was not sealed and could be contaminated.

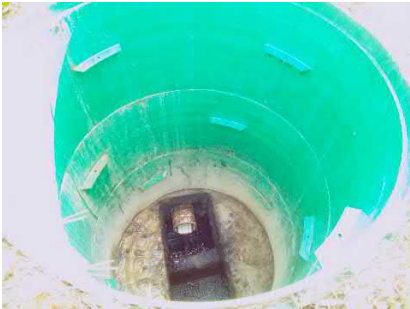
Septic Systems

Inspected by All Repair Septic. No defects observed, though water level was unusually low; this could either indicate recent pumping or a crack in the tank. Due to circumstances, this is not a defect, though I recommend further observation.

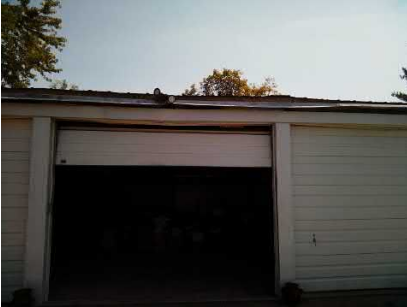
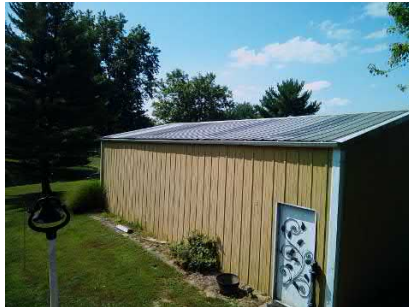
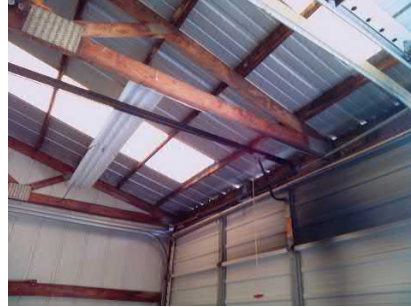
Building was settling, causing roof sag and beams to detach from posts. Several indications of rust on the underside of the steel roof and waterlogged structural supports, indicating moisture intrusion throughout structure. Storage units were installed on trusses, which are not engineered to support weight beyond themselves and the roof. Removal of storage units and further inspection and correction by qualified roofing contractor recommended.

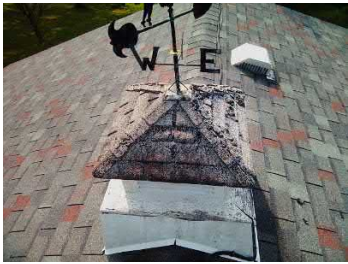
Roof

Vent penetration had surface covering deterioration, exposing wood substructure, which showed signs of rot. This roof covering is potentially asbestos, and should be further inspected for confirmation.
